### Recall Campaign: 4877-1767, 8.1L Throttle Body

Gas engines 8.1

#### Product Safety Recall

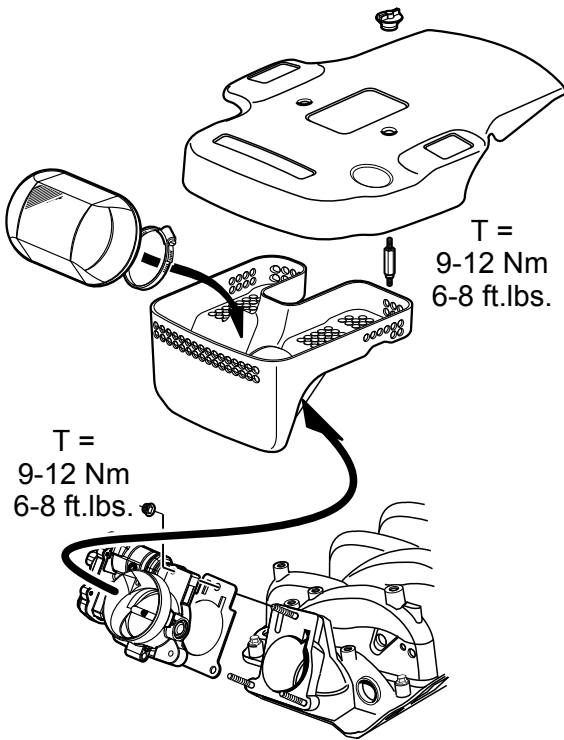
The campaign mark is two white paint dots on the throttle body. See illustration.

Inspect the throttle body for the campaign mark. If present file a warranty claim for the inspection, see below.

If no campaign mark is present the throttle body must be replaced.
